# DELAMINATING PAINT IN AN 18<sup>TH</sup> CENTURY CANVAS WALL PAINTING

A Case Study at the von Echstedt Manor

Degree project for Master of Science with a major in Conservation  
2021, 30 HEC  
Second Cycle  
[2021:26]

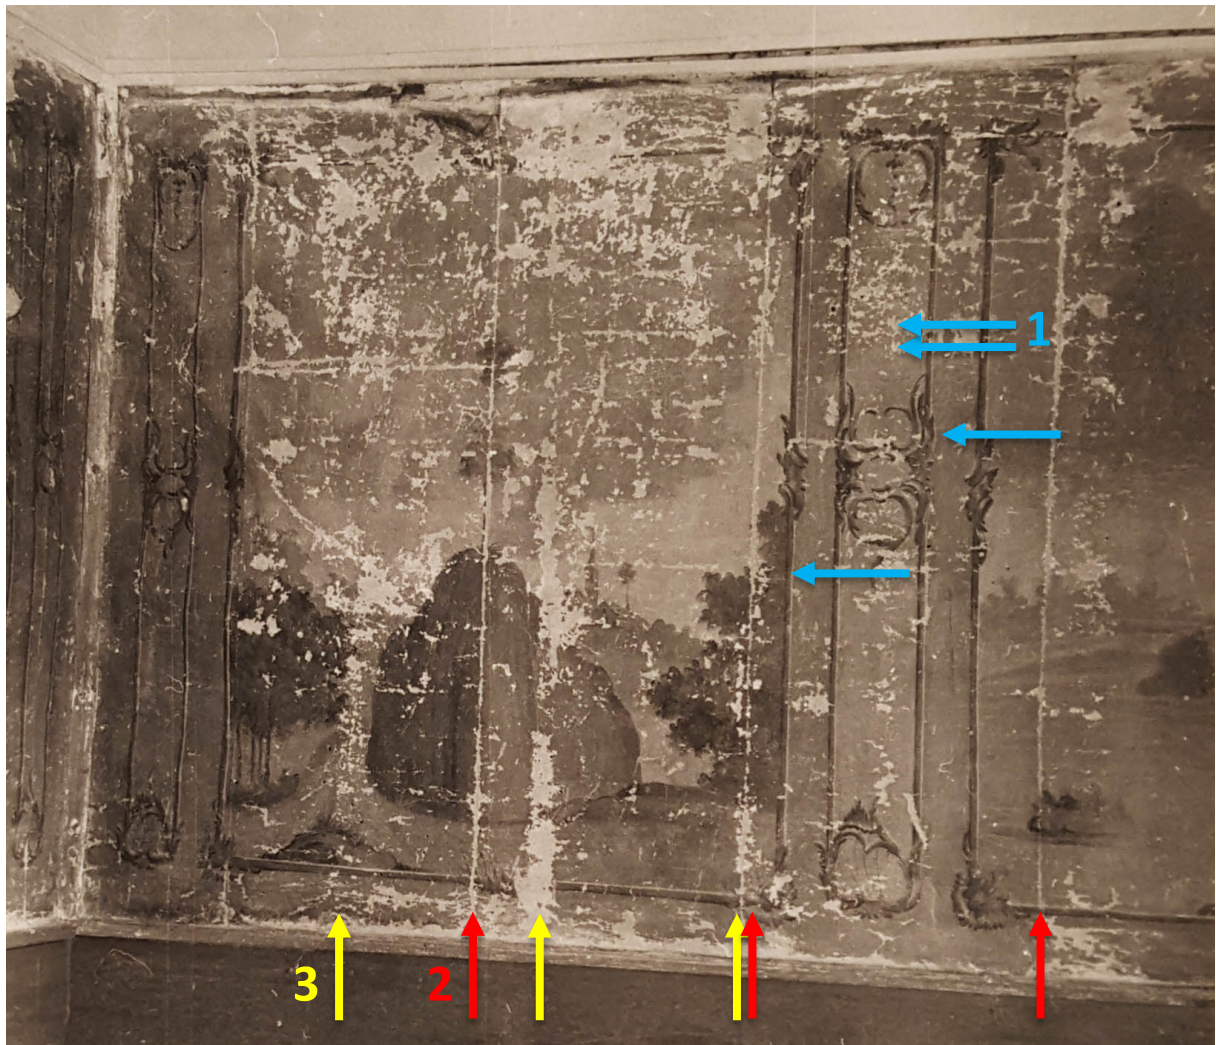
In the above-mentioned protocol by von Schoultz (1957), there are four photographs showing the wall paintings in the Green Chamber during and after the restoration 1955. One photograph shows the left part of the south wall that today has the most severe deterioration. The photograph was taken after the wallpaper was removed, but before the losses were retouched (figure 5 below). Three patterns can be distinguished in how the losses are distributed on this part of the south wall. There are losses forming horizontal lines that seem to correspond with the edges of the underlying timber. The patterns of losses in a vertical direction seem to be of two kinds. There are the losses on, and in the proximity of, the seam where the stretches of canvas are stitched together. The other pattern of vertically oriented losses is seemingly not corresponding with the support structure. These areas are less defined and approximately 50 cm apart, which is the standard width of industrially produced wallpapers from the 1830s and onwards (Broström & Stavenow-Hidemark 2004, p. 268). One cannot know for sure what caused the losses seen in figure 5, or what the condition of the wall painting was when the first wallpaper was put up. Anyhow, the losses supposedly corresponding with the wallpaper edges, suggest that the losses may to a large extent have to do with the process of repeated wallpapering and the removal of the same.

Figure 5. Photograph of the left part of the wall painting on the south wall during restoration 1955. Three different patterns can be recognized in the losses: 1. Horizontal lines probably corresponding to edges of the timber behind the canvas, 2. Losses on canvas seams, 3. Vertical lines approx. 50 cm apart. Photographer Gösta von Schoultz, copyright Värmlands museum. Photograph cropped by the author.

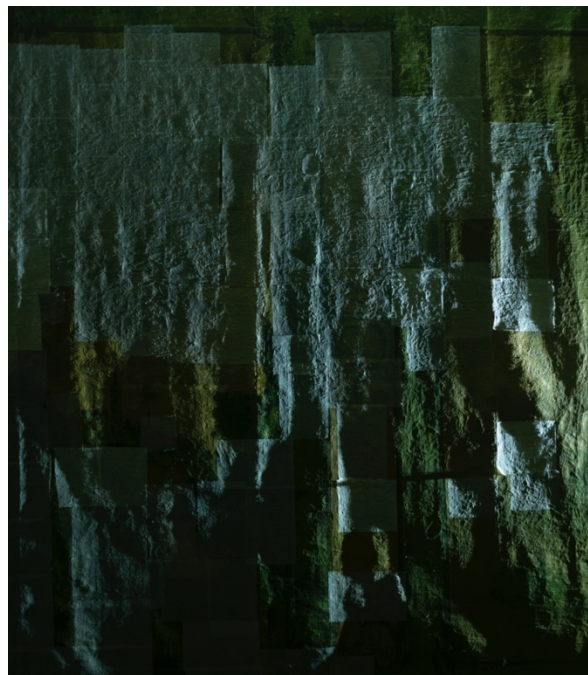
Figure 7. Detail of the wall painting on the south wall in raking light. The area most affected with delamination is also the area where canvas has the most deformations.

left side of the painting on the south wall has the most prominent deformations (fig. 7). There are a few holes, no larger than 2 cm in diameter, where the edges of the fabric are worn. In the upper edge of the canvas on the south wall, the nail holes from a previous attachment are visible in between the present nails. In some places the seams attaching the separate stretches of canvas are open, and the stitching thread is missing.

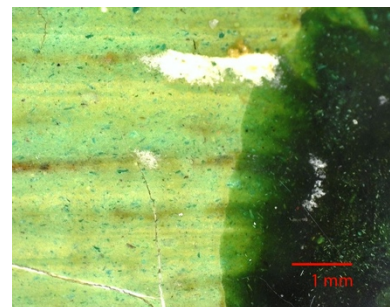
Figure 13. Micrograph of area 14. The dark green paint appears transparent.

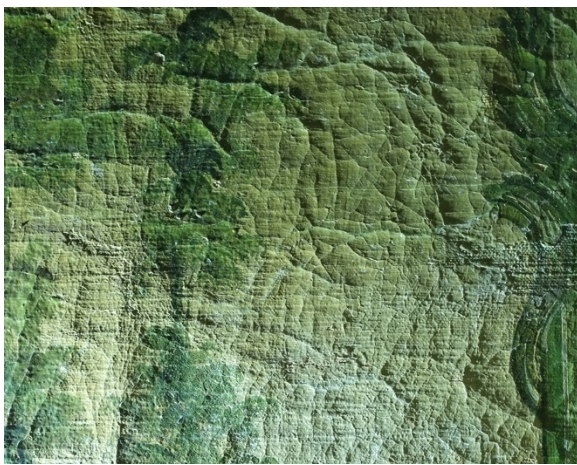
A network of cracks is present all over the original paint layers on the two canvasses. The cracks form ridges that are seen in the raking light photographs (fig. 14). For the most part the cracked paint is well adhered to the canvas, but in some places the paint layers are delaminating from the ground layer. The area most affected by delamination of the paint layers from the ground layer, is the earlier mentioned area situated to the left on the south wall. This area has for the most part protective facing of Japanese paper, but the delamination phenomena can be studied in adjacent areas without facing (fig. 15). The area most affected by delamination is also the area where the paint is most significantly darkened. The light sky above the church and hill is seemingly the area most affected by the darkening (fig. 16). An unvarnished area on the south-east wall appears to be one of the best-preserved areas of the painting. The paint in this area has a fine craquelure, but the cracks are not forming ridges as in other areas (fig. 18, fig. 19). It does not have the problem with delamination seen in other areas of the painting.

Figure 14. Detail in raking light of an area by the two trees in the right landscape on the south wall. The pattern of cracks is visible.

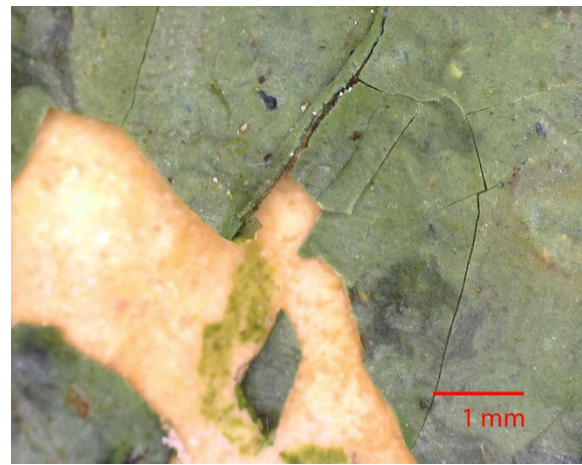
Figure 15. Micrograph of area 3. The paint layers are delaminating from the ground layer.

The problem with reoccurring delamination of the paint layers is more or less restricted to the area to the left of the painting on the south wall. The problem seems possible to track back to the restoration in the 1950s, when layers of wallpaper were removed from the wall paintings. The extensive paint losses from this intervention are visible in archival photographs, and the retouches of these losses can be seen in the painting today. Extensive cracking, delamination and paint loss result in more surface area, as well as exposure of the porous ground layer otherwise protected by paint. More surface area implies that external factors like the climate, and added materials like varnish and adhesive, have more material to interact with and adhere to in that specific area, compared to in other areas.

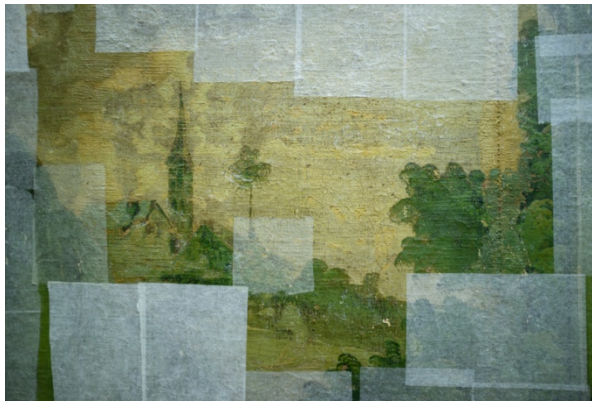
Figure 16. Detail of the left landscape on the south wall in normal light. Retouches from the 1950s are seen as light areas around the church tower and along the seam in the canvas to the right. Above the church tower and in the top right corner some of the darkened original paint is visible.

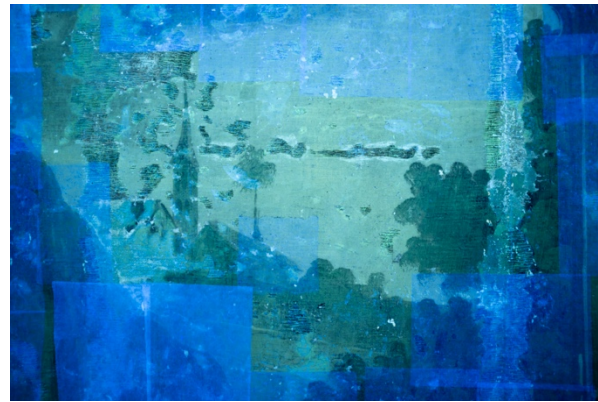
Figure 17. The same area in UV-light. Thin lines of a watercolor retouch, probably from the 1992 intervention, are visible on top of some of the 1950s retouches. The watercolor appears black in UV-light. Wax used for consolidation is visible as well and appear light blueish, for example in the crown of the tree beside the church.

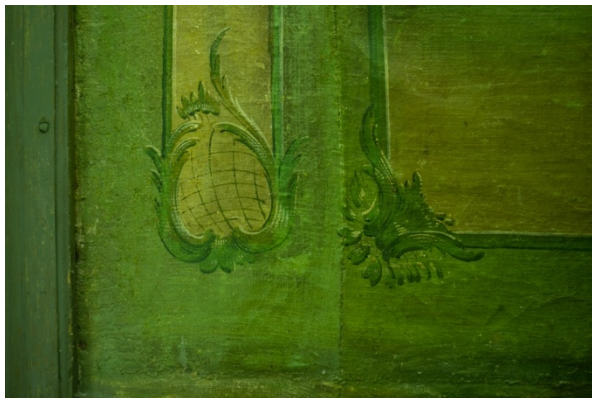
Figure 18. Detail of an unvarnished area in the bottom left corner of the wall painting on the east wall. The unvarnished green paint appears a little lighter and brighter.

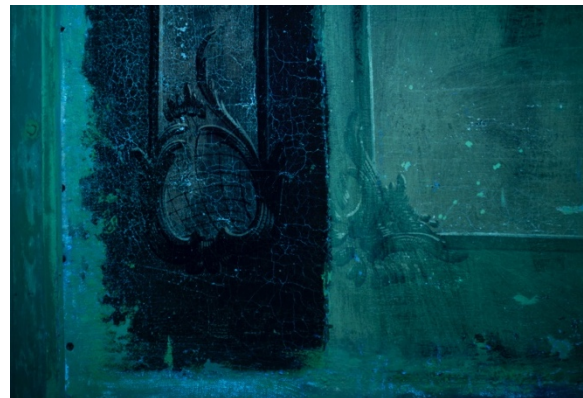
Figure 19. The unvarnished area in UV-light. The unvarnished area appears dark. A pattern of very fine cracks is seen as white lines.

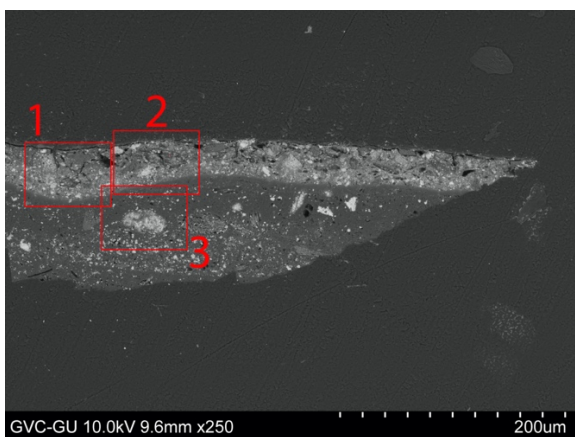
Figure 27. Areas in the BSE- image of cross section 5.1. where signs of lead soap formation are detected. See close-ups in the following images.

The SEM-BSE images together with the result from SEM-EDX suggest there is lead soap present in the paint layers. Delamination of paint layers is a degradation phenomenon associated with metal soaps in paintings, as is increased transparency and darkening. The area in the painting most affected by delamination is also the area where the darkening of the paint is most striking. The formation of metal soaps is enhanced by water molecules, both in the form of humidity and water, and by solvents. The amount of water added to the paint layers during consolidation with sturgeon glue can be quite significant, and varnish is applied with solvents. As mentioned earlier, both water and solvents have the ability to hydrolyze the ester bonds in the triglycerides in the oil binding medium, and thereby enable the formation of metal soap (pp. 16-17). Oils can also promote the formation of metal soaps, by being a source of free fatty acids. Since the 1950s retouches seem to be oil-bound, and are extensive in this area, it is possible that they too have promoted the supposed lead soap formation. In this way, by paint loss and subsequent interference by other factors, it is possible that the 1950s wallpaper removal created an area of the painting that has the right conditions for lead soap to be formed.

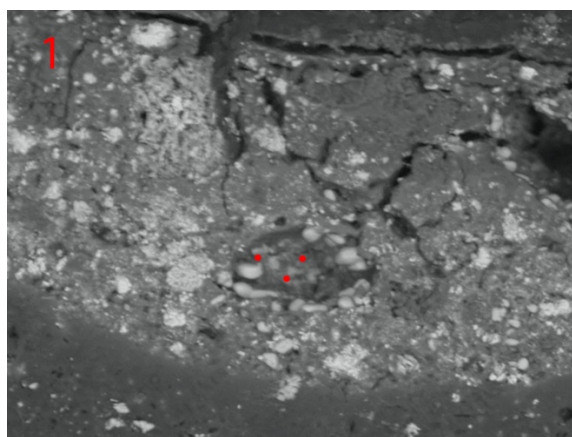
Figure 28. The grey area where the red dots are is possibly an aggregate of lead soap. The red dots mark spots for EDS-analysis. Lead and oxygen the are elements detected.

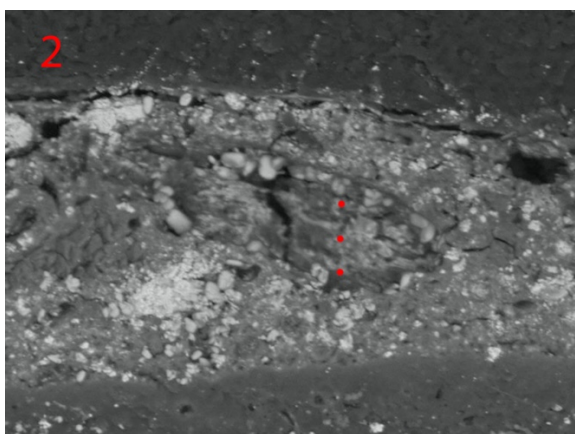
Figure 29. Grey amorphous area where the red dots are is possibly an aggregate of lead soap. The red dots mark spots for EDS-analysis. Lead and oxygen the are elements detected.

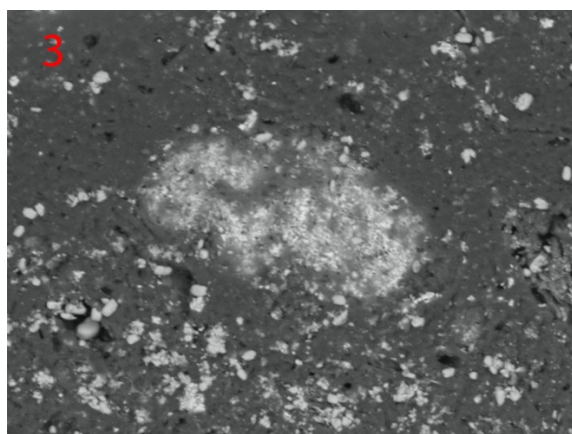
Figure 30. A big lead white particle in cross section 5.1. The undefined, disintegrated edges of the pigment particle may be a sign that metal ions are migrating from the pigment surface to form lead soap.

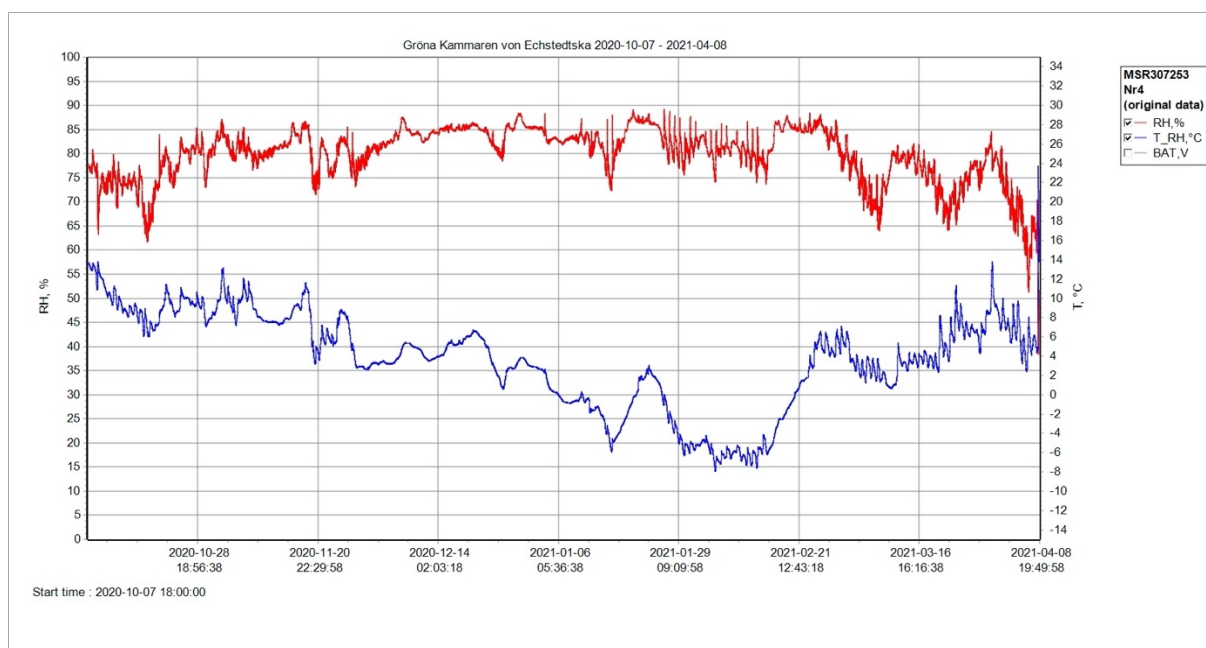
Climate data from the Green Chamber is collected over six months, October 2020 – April 2021. The result show temperatures down to  $-8^{\circ}\text{C}$  and a relative humidity (RH) in the range 75 – 88 % in the winter months, and in some periods the daily fluctuation in RH is around 10 % (fig. 32). Of the two dataloggers installed in October, only one recorded data until April. The data-logger installed in the left corner of the south wall only recorded until the beginning of November, when mice apparently cut the cable connecting the sensor to the logger. The recorded data so far is compared between the two loggers. The climatic differences between the two locations appear to be minimal. It is concluded that the data recorded by the logger installed on the right side of the painting on the south wall is probably representative for the whole room. During the autumn and winter when the museum is closed for visitors the windows are completely blinded, implying that there is no local radiant heat from sunlight reaching the wall paintings during this period. No mould growth is detected on the wall paintings in the Green Chamber, even though the RH is far above the 60 % that is considered safe from this aspect. The low temperature in the Green chamber during the periods with high RH may be a factor hindering the mould growth, which is something that has been observed in other historic houses with unregulated indoor climate (Schulze 2013, p. 88).

Figure 32. The indoor climate in the Green Chamber in the period Oktober 2020 – April 2021 recorded with an MSR datalogger. Blue line shows the temperature in  $^{\circ}\text{C}$  with number on the right y-axis. Red line shows the relative humidity (RH) with a scale in percentage on the left y-axis.

Lead soap or no lead soap, the climatic conditions in the von Echstedt manor constitutes a risk for a painting with severe paint delamination. It is important in this case to notice that despite the rather extreme climate, an RH up to 88% and temperatures down to -8°C, the vast majority of painted surfaces inside the manor are well preserved. The same can be said about the paintings in the Green Chamber. Although one area is severely deteriorating, the paintings are for a large part in a rather good condition. This indicates that the climatic conditions cannot be the factor that initiates the deterioration in the affected area, even though the climate may be making the problem worse. The coldest temperature
